# INSPECTION REPORT

Inspection Date: Tuesday, September 10, 2019

Prepared by: Steve Lukings

House Whisperer Home Inspections

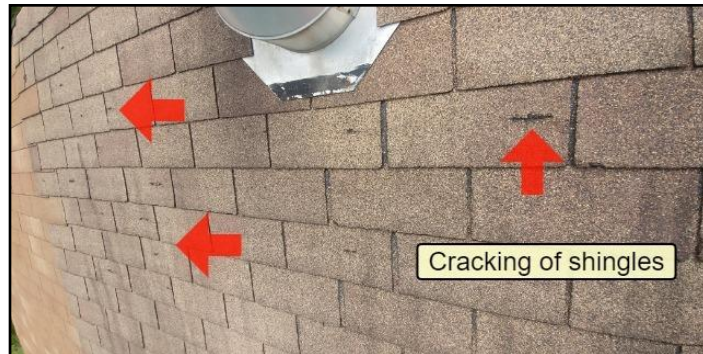
**2. Condition:** • [Cracks](#)

If you can cover cracks with some roofing tar, it should increase the time left before having to replace shingles. This will help to ensure/reduce the chance that no leaks happen.

**Location:** Rear Exterior Roof

1. Cracks

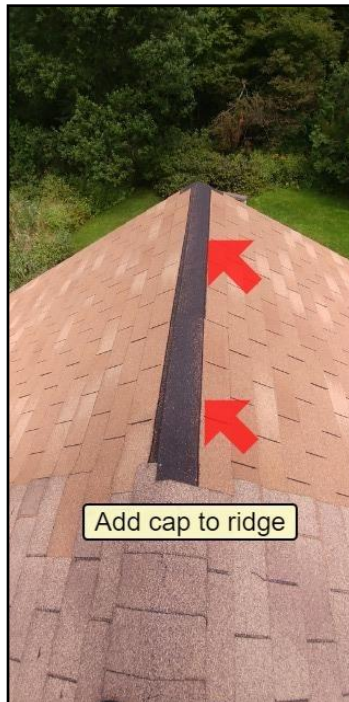
**3. Condition:** • [Missing, loose or torn](#)

**Location:** Right Roof

2. Missing Cap

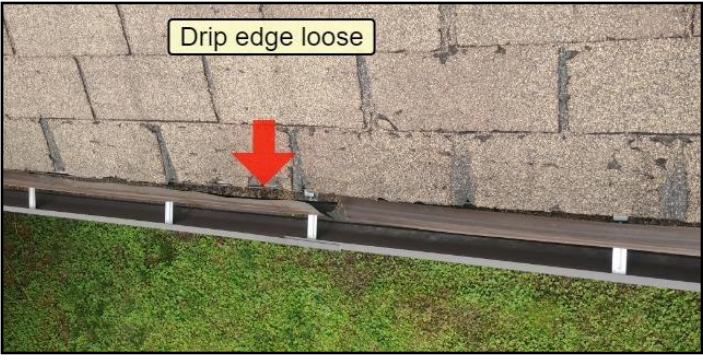
**4. Condition:** • [Vulnerable areas](#)

**Location:** Left Exterior Roof

3. Damaged/loose

Fix drip edge and secure it. Repair where shingles are damaged along that edge.

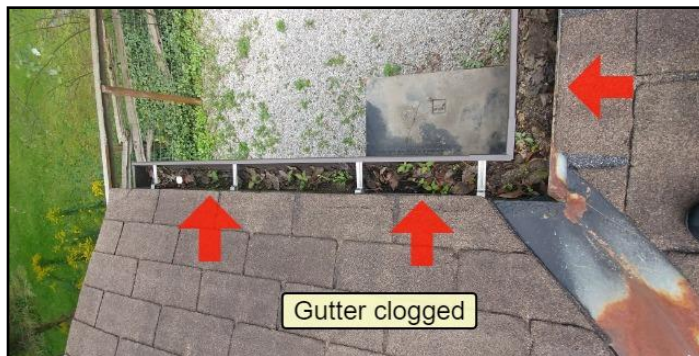
**5. Condition:** • Dirty/debris

**Location:** Roof

4. Dirty/debris

**Task:** Clean

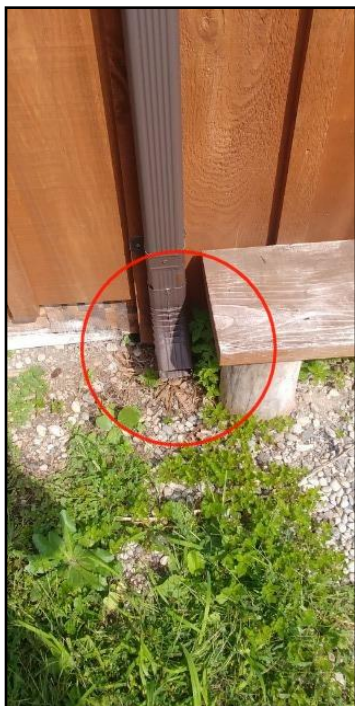
**6. Condition:** • [Should discharge 6 feet from building](#)

**Implication(s):** Chance of water damage to contents, finishes and/or structure

5. Should discharge 6 feet from building

**Task:** Improve

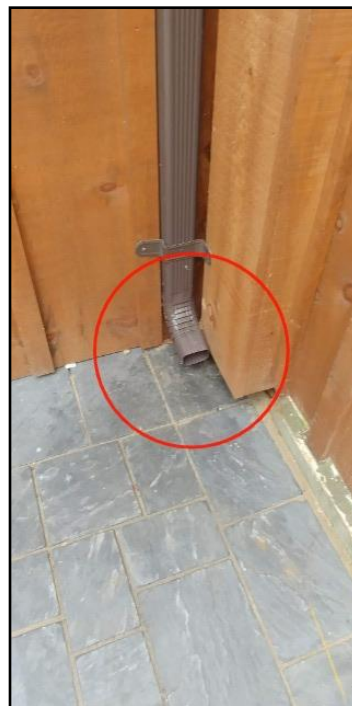
6. Should discharge 6 feet from building

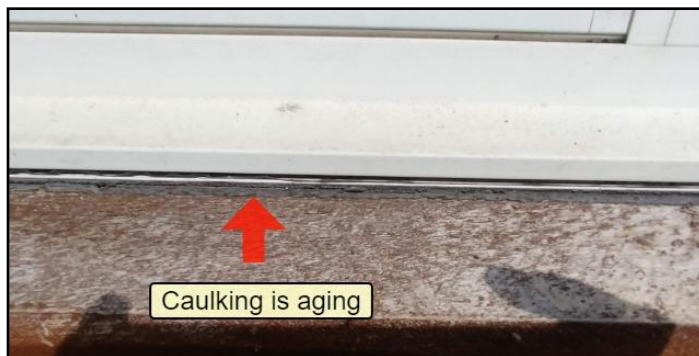
**7. Condition:** • Paint and Caulking - deteriorated / missing

Just monitor and replace when needed. As discussed: the caulking is aging and hardening. It will need to be replaced in the next couple of years to prevent water and drafts from entering

**Location:** All windows

7. Paint and Caulking - deteriorated / missing

**Task:** Repair

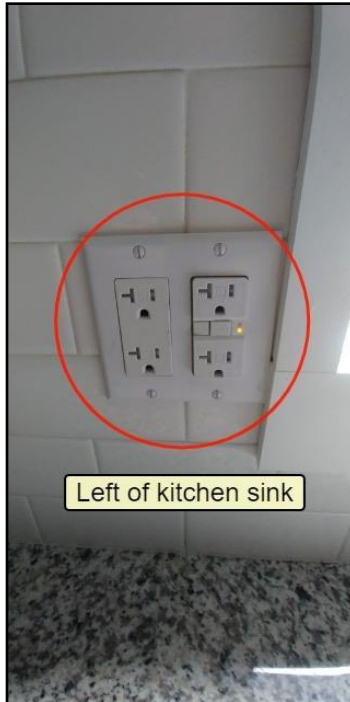
Loose in wall. GFCI kept tripping.

**8. Condition:** • [Test faulty on GFCI/GFI \(Ground Fault Circuit Interrupter\)](#)

**Implication(s):** Electric shock

**Location:** Kitchen

8. Test faulty on GFCI/GFI (Ground Fault...

**Task:** Repair or replace

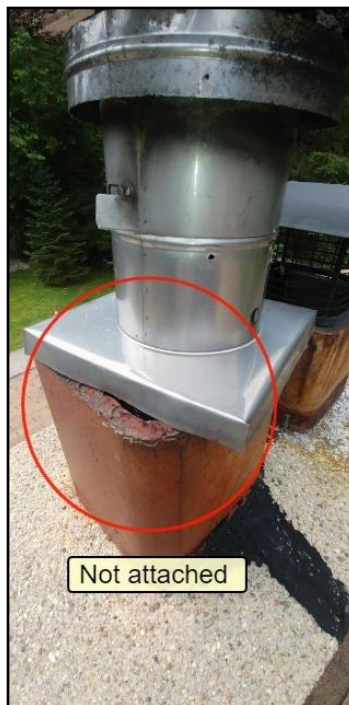
**9. Condition:** • [Pieces poorly connected](#)

**Implication(s):** Equipment not operating properly | Hazardous combustion products entering home | Increased fire hazard

**Location:** Roof

**9. Poor connection to chimney**

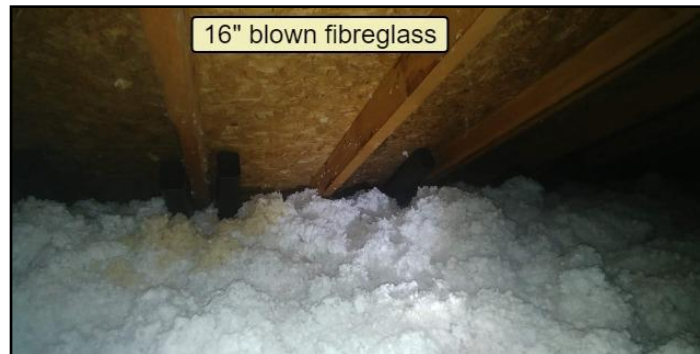
10. 16 inches

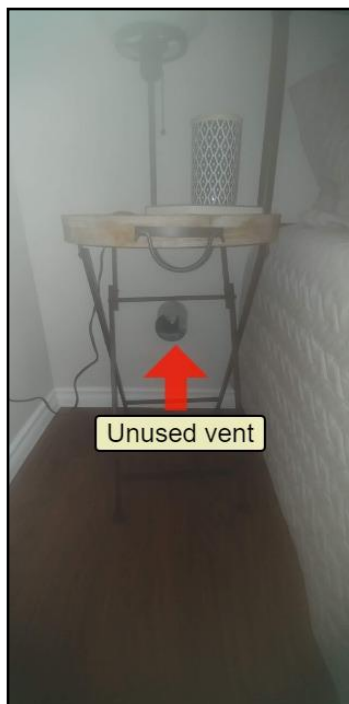
**10. Condition:** • Other

**Location:** Master Bathroom

14. Other

Insulate and tightly seal unused vent

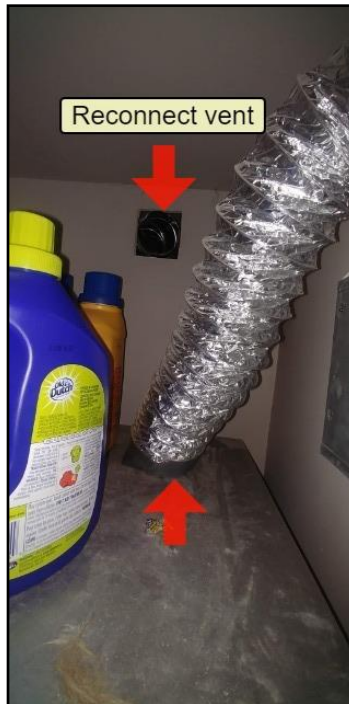
**11. Condition:** • [Not vented to exterior](#)

**Implication(s):** Chance of condensation damage to finishes and/or structure

**Location:** Laundry Area

15. *Not vented to exterior*

**Task:** Repair
